ADVANCED INSPECTION TECHNOLOGY

XSpectra®
for spreadable
creams

Introduction

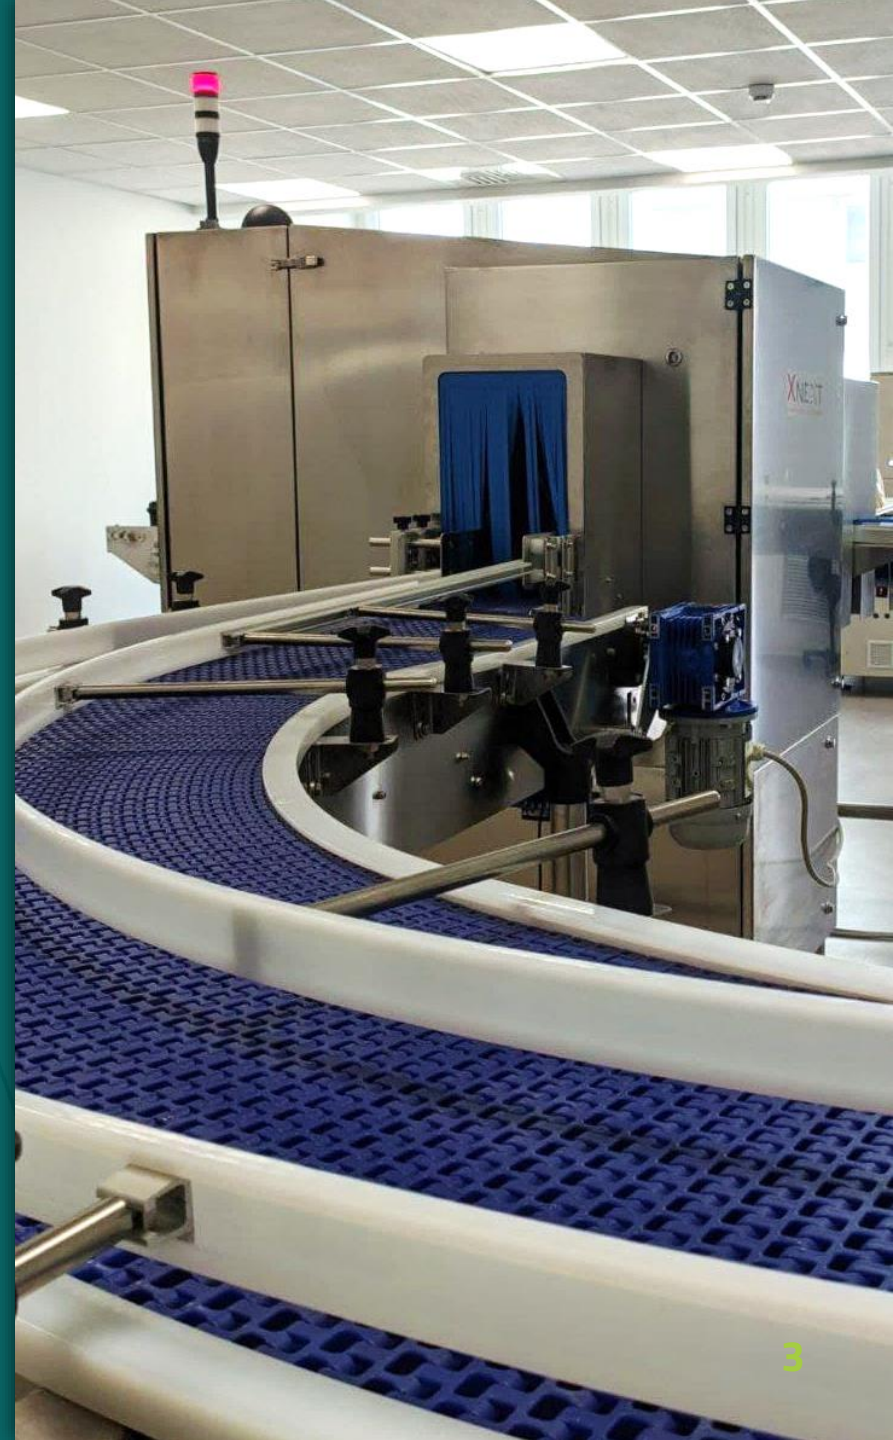
The Equipment

Tests were carried out at the Xnext Demo Center using a demo machine, equipped with XSpectra®, placed on a 6-meter conveyor loop. The aim was to recreate the typical operating conditions of a processing line for this type of product in order to carry out realistic tests.

The Products were inspected mainly using a geometric configuration of the inspection system in which the X-ray generator and the detector are placed in a lateral position with respect to the direction of movement of the Product.

The demo-machine used for testing has fixed distances in terms of source-product and product-detector. Therefore, when a dedicated machine is built, the geometric configuration can be further optimised, facilitating the operation of the foreign body detection software. We also do not rule out the use of an X-ray source more suitable for the type of product being inspected.
